National Highway
Traffic Safety
Administration

Case Vehicle (A): 1999 Mercury
 Type: Sable GS, 4-door sedan
 Driver: 45-year-old female
 CDC: 12-FCEW-4

SITUATION

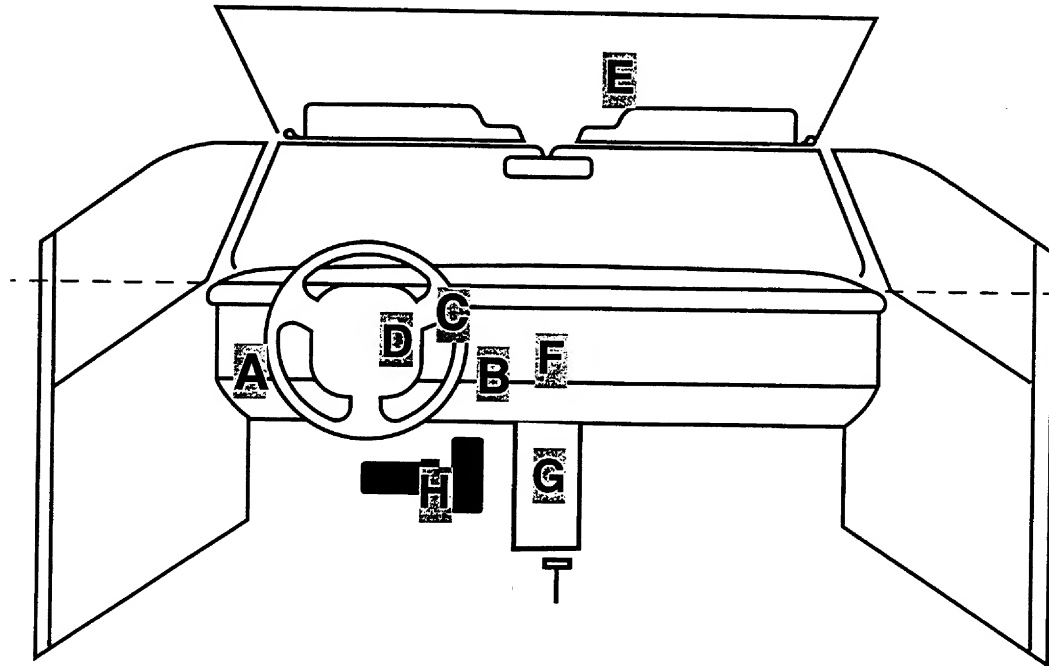
VEHICLE OCCUPANT CONTACT DIAGRAM

- A = knee bolster left - scuffed and dented**
- B = knee bolster right - scuffed and dented**
- C = steering wheel rim and spokes - scuffed and deformed**
- D = airbag module cover - deformed**
- E = roof - mark**
- F = climate control knob - cloth imprint**
- G = center instrument panel - black mark and dented**
- H = gas and brake pedals = deformed**

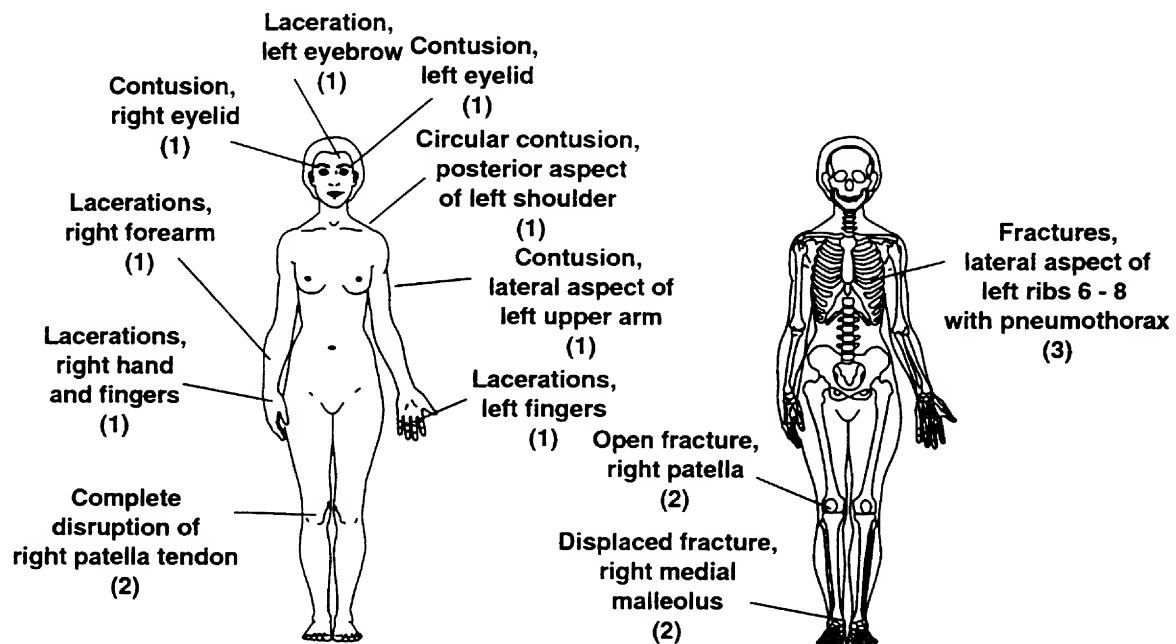
INDICATE LOCATION OF INJURIES.

Injury Description	A.I.S.	Injury Source		
		Definite	Probable	Possible
Laceration, left eyebrow	1		Airbag	
Contusion, left eyelid	1		Airbag	
Contusion, right eyelid	1		Airbag	
Fractures, lateral aspect of left ribs 6-8 with pneumothorax	3			Steering-wheel/airbag
Circular contusion, posterior aspect of left shoulder	1			Interior loose object
Contusion, lateral aspect of left upper arm	1			Driver door interior (airbag fling)
Lacerations, right forearm	1			Center instrument panel/ broken glass
Lacerations, right hand and right fingers	1			Center instrument panel/ broken glass
Lacerations, left fingers	1			Driver door interior (airbag fling)
Open fracture, right patella	2	Knee bolster/steering column		
Complete disruption of right patellar tendon	2	Knee bolster/steering column		
Displaced fracture, right medial malleolus	2		Brake pedal	
<u>Maximum A.I.S. Level</u>	<u>3</u>			
<u>Injury Severity Score</u>	<u>14</u>
